**DECLARATION OF KYLE LUTZ IN  
SUPPORT OF DEFENDANTS'  
MOTION TO DISMISS OR, IN THE  
ALTERNATIVE, MOTION FOR  
SUMMARY JUDGMENT**

## Travis Moreda Dairy List of Improvements

# Representative Photographs of Improvements

### CONFINED ANIMAL FACILITY COMPLIANCE INSPECTION

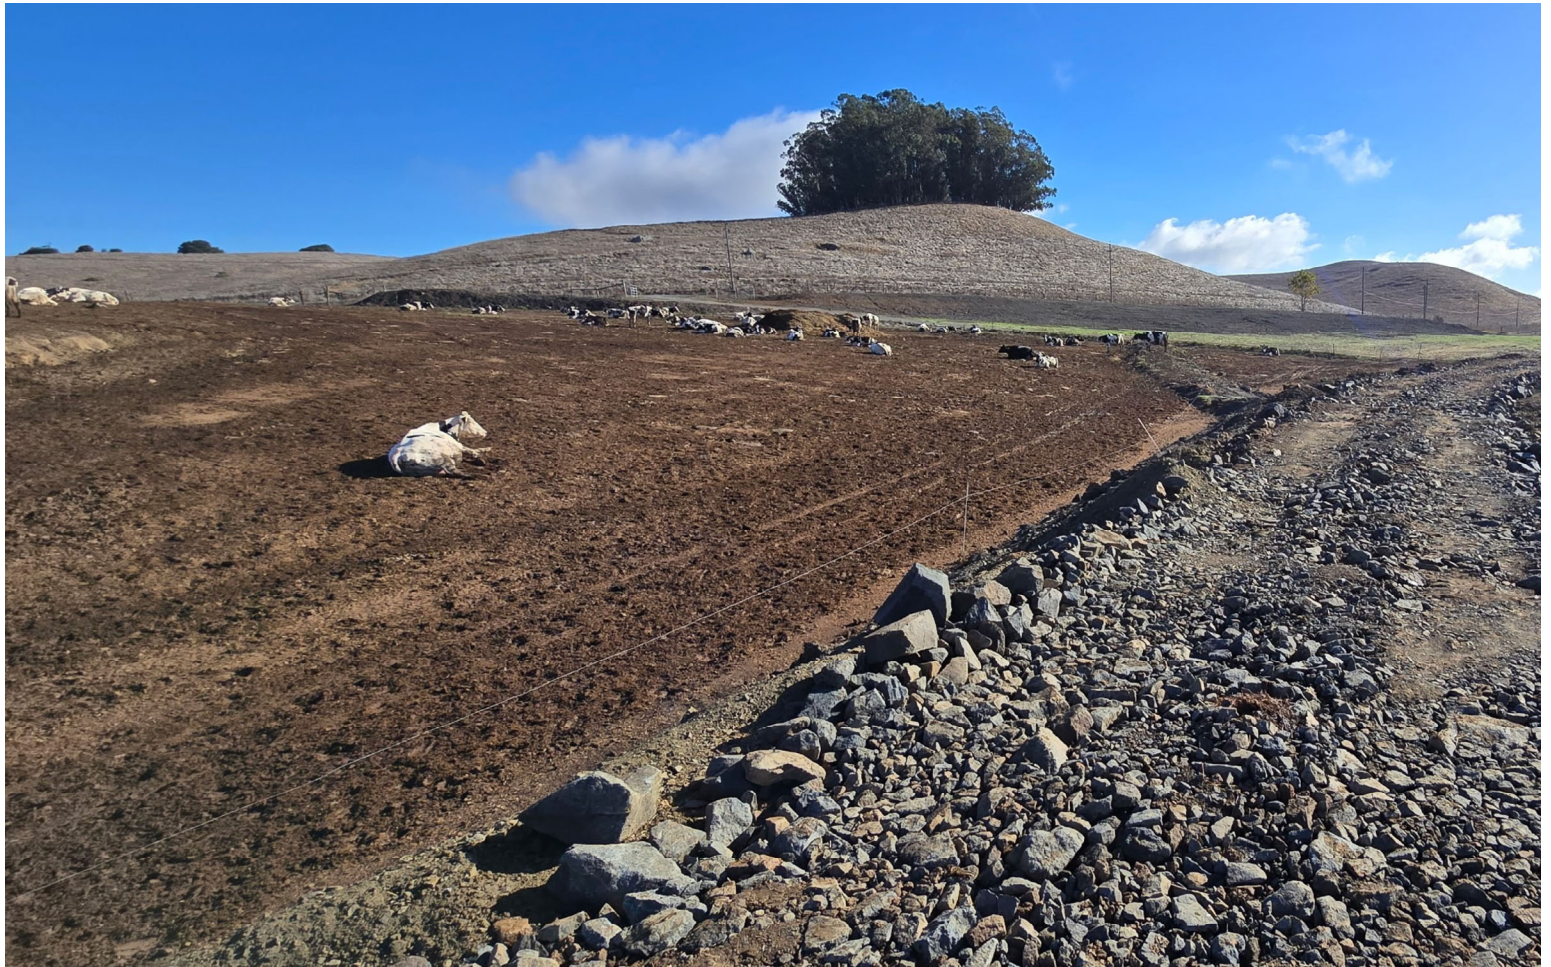
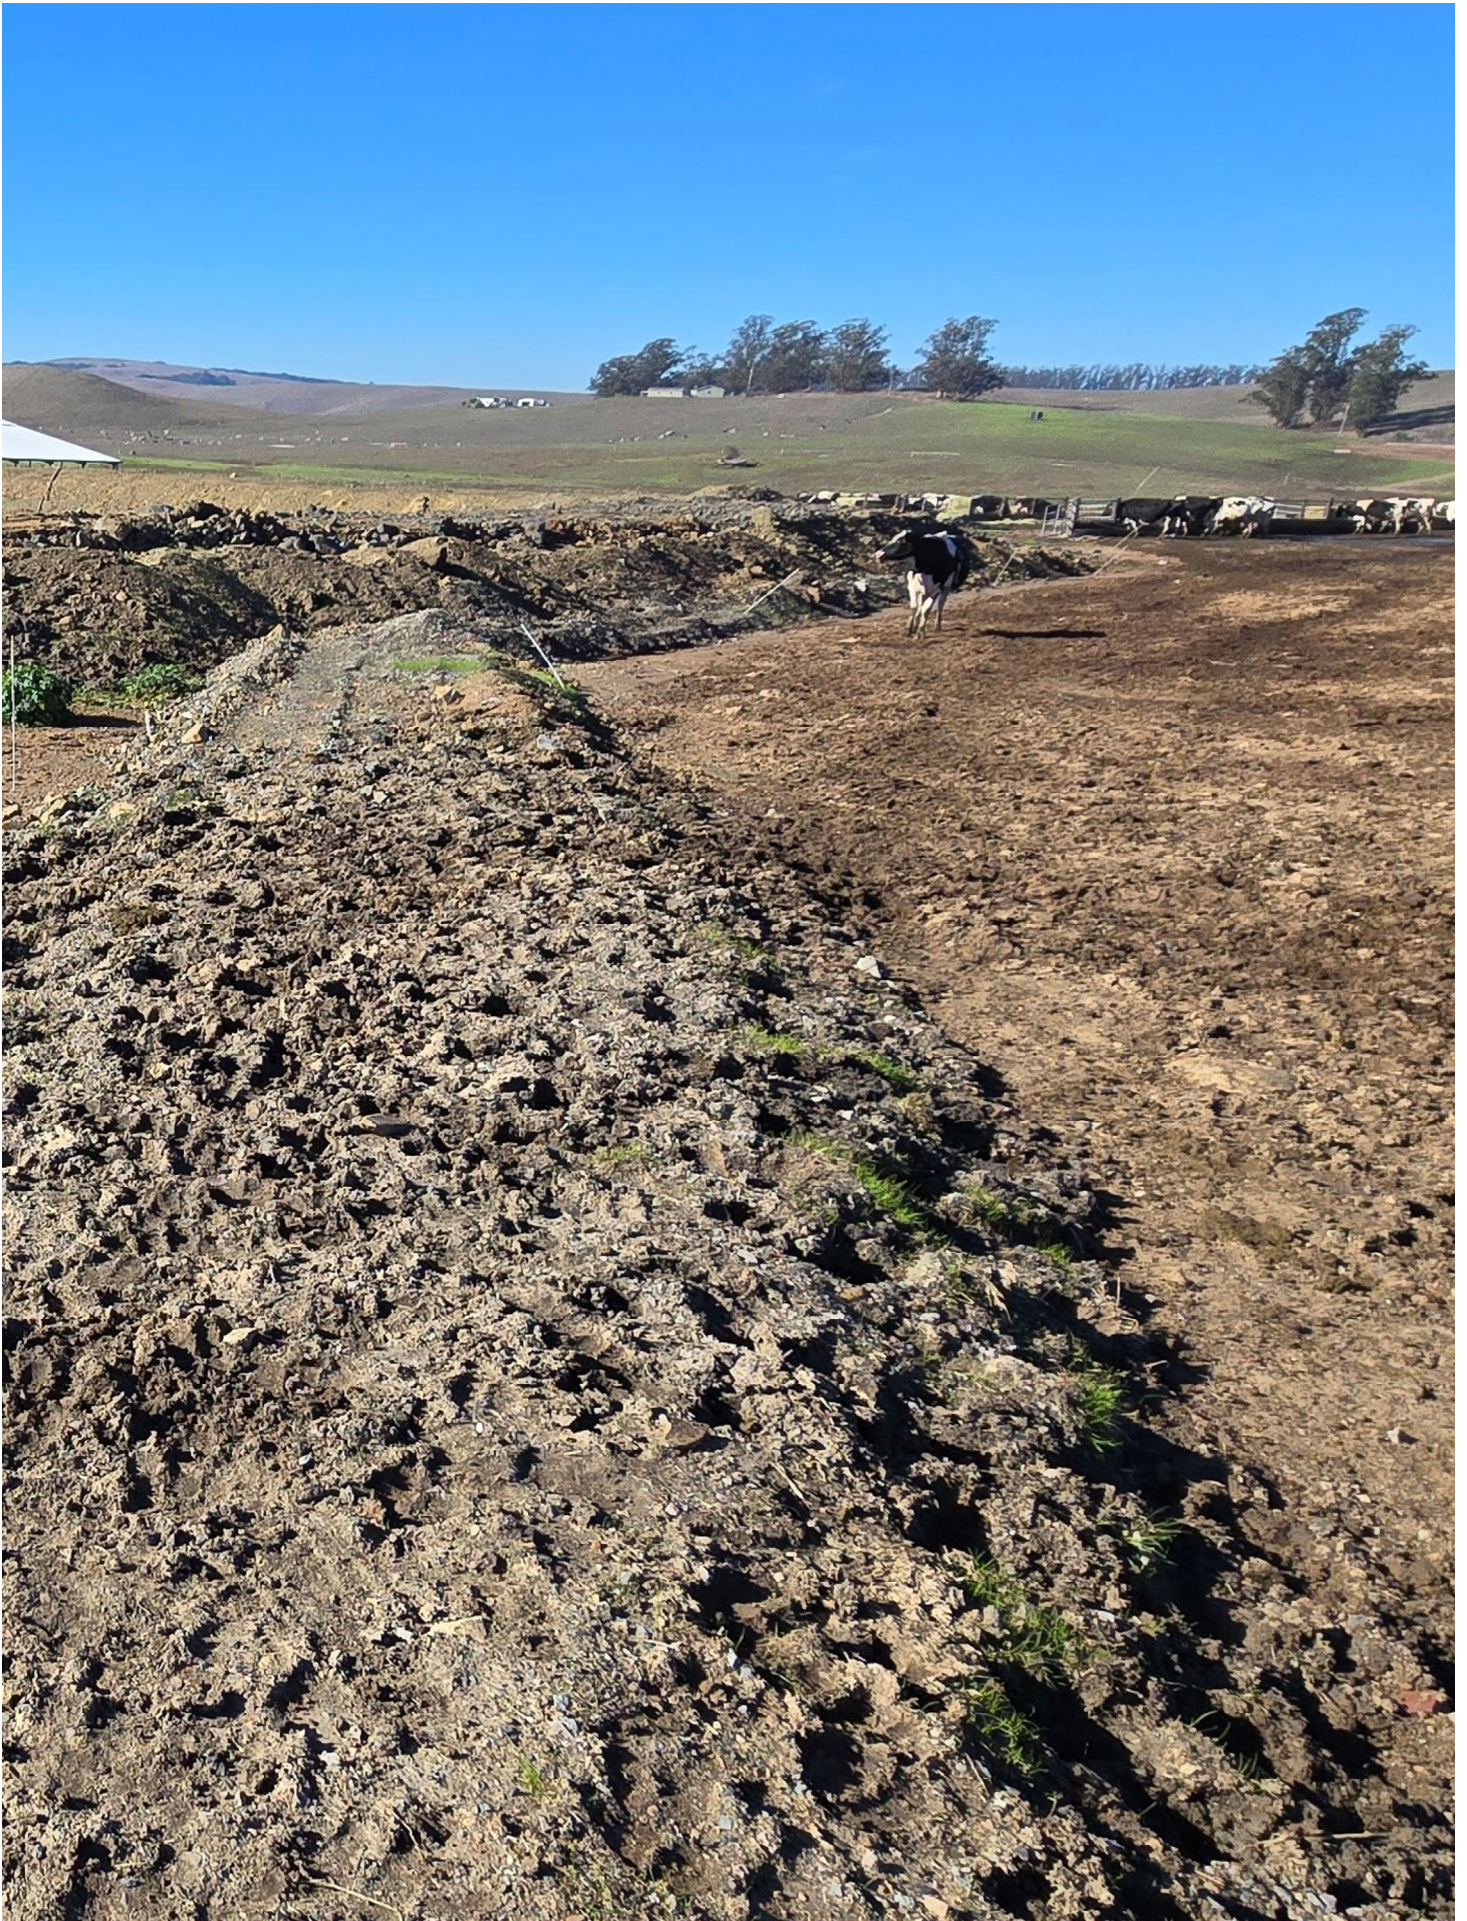
Berm

- 4.) Contain Potential Runoff from Hill Utilized By Livestock: This area consists of a hillside that livestock have access to year-round. The dairy has implemented a berm which captures potential runoff resulting from usage of this area and conveys it to the lagoon system where sufficient storage capacity exists.

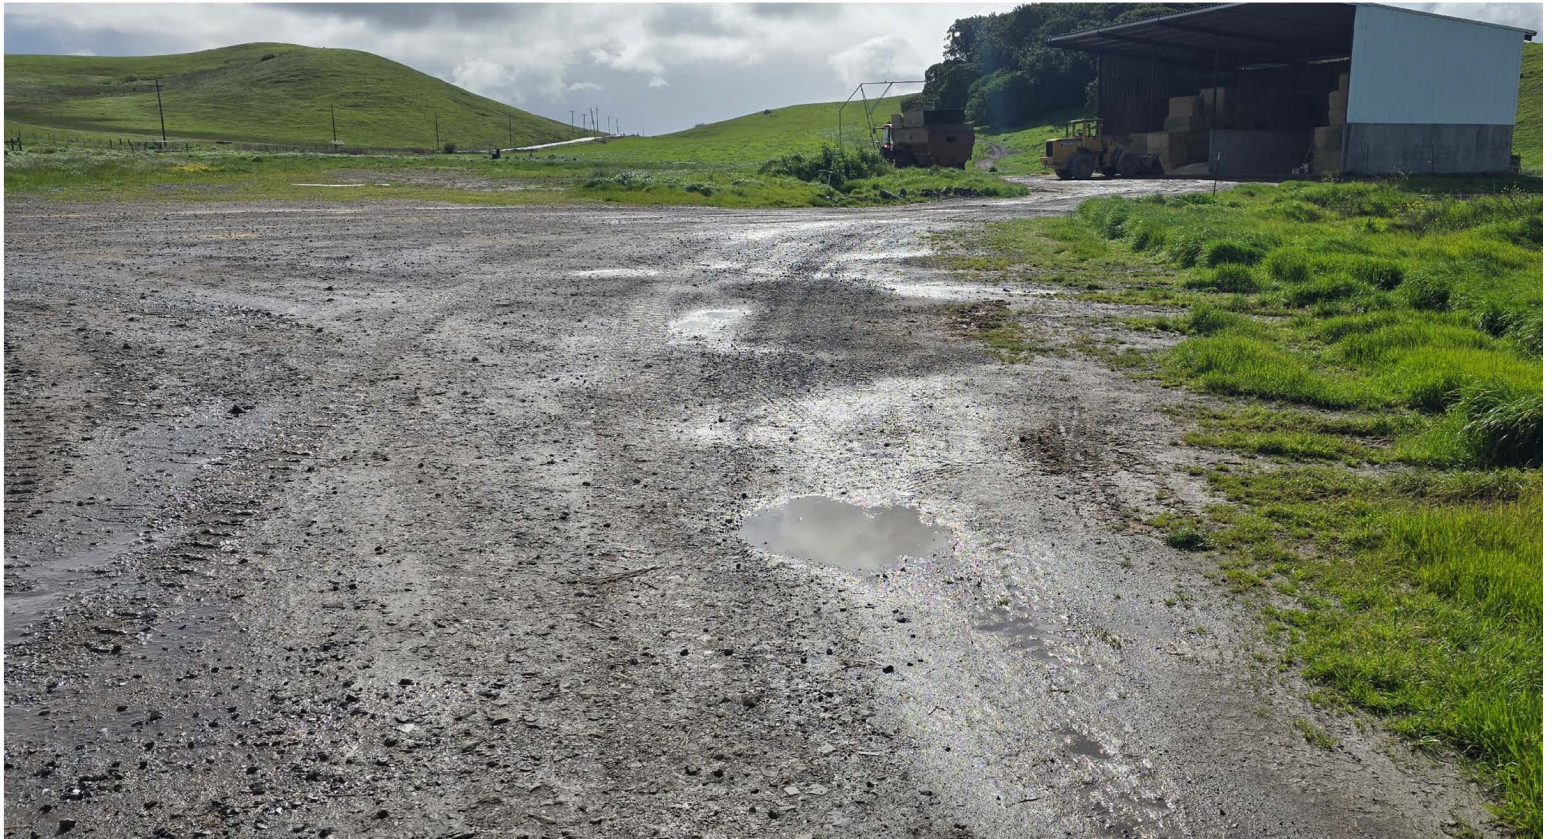
Commodity area cleared; commodities stored in Commodity Barn

- 13.) Silage Pile & Outdoor Commodity Piling Seasonal Use: Improvements were made to storage of silage, refusals, and some bulk commodities. The dairy will not store commodities on this area during the winter months where the presence of rainfall may present a threat to water quality. Instead, the dairy will enhance the use of their existing roofed commodity barn to store commodities during the winter.

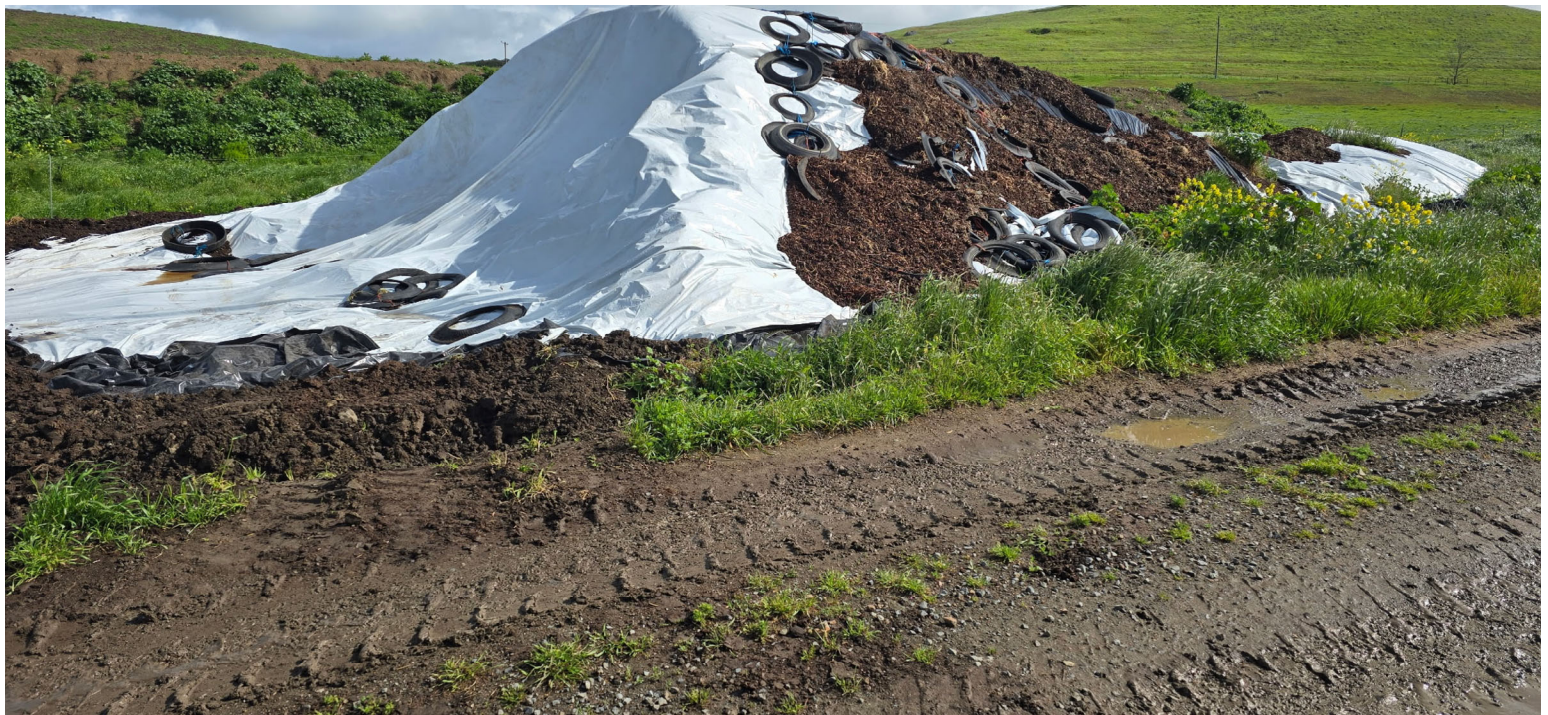
Compost bermed and tarped

- 10.) Composting Area Containment/Tarping: Improvements were made to the composting area. The dried manure pile is fully tarped prior to the rainy season to prevent exposure to rainfall. A berm has also been implemented below this area so that any potential seepage from the pile or runoff would be captured by the berm and conveyed to the existing lagoon system.

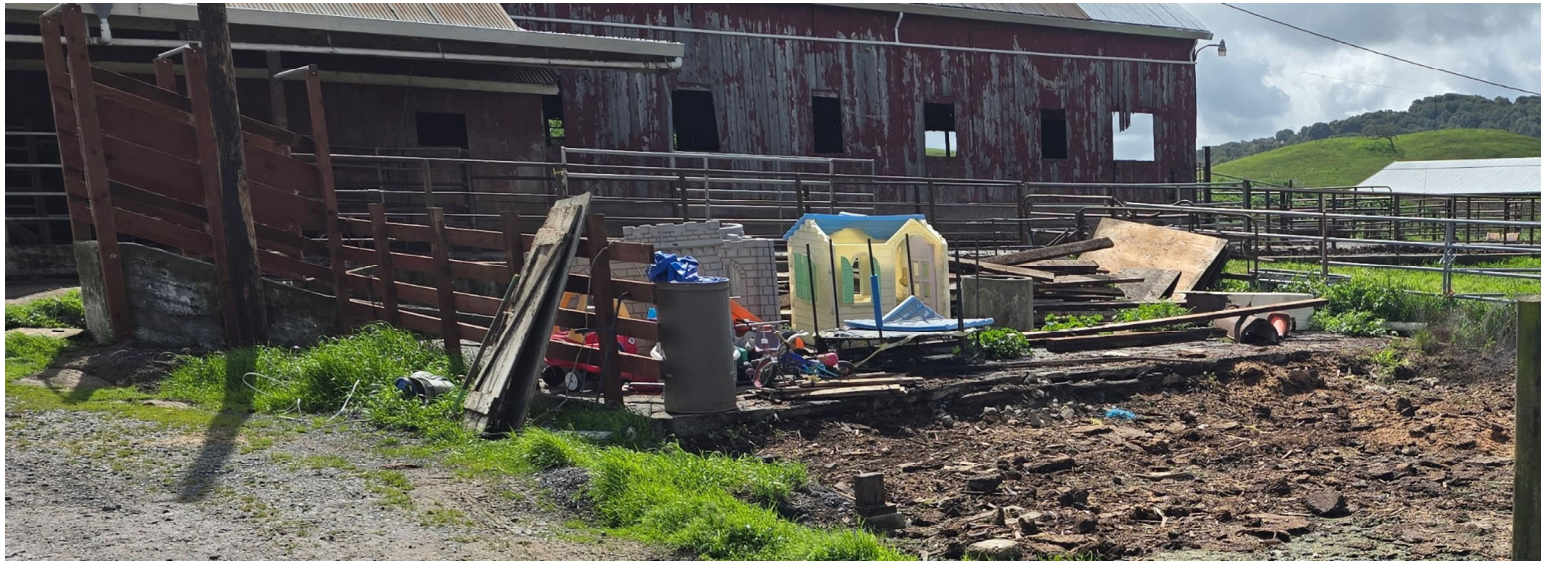
Corral scraped clean and to be used seasonally

- 7.) Corral by the Loading Chute: Prior to this improvement, the corral was utilized sparingly year-round with manure being scraped as needed. The corral by the loading chute was scraped clean and pressure washed. This area will no longer be utilized during the rainy season, and it will be limited to seasonal use to prevent any water quality issues.

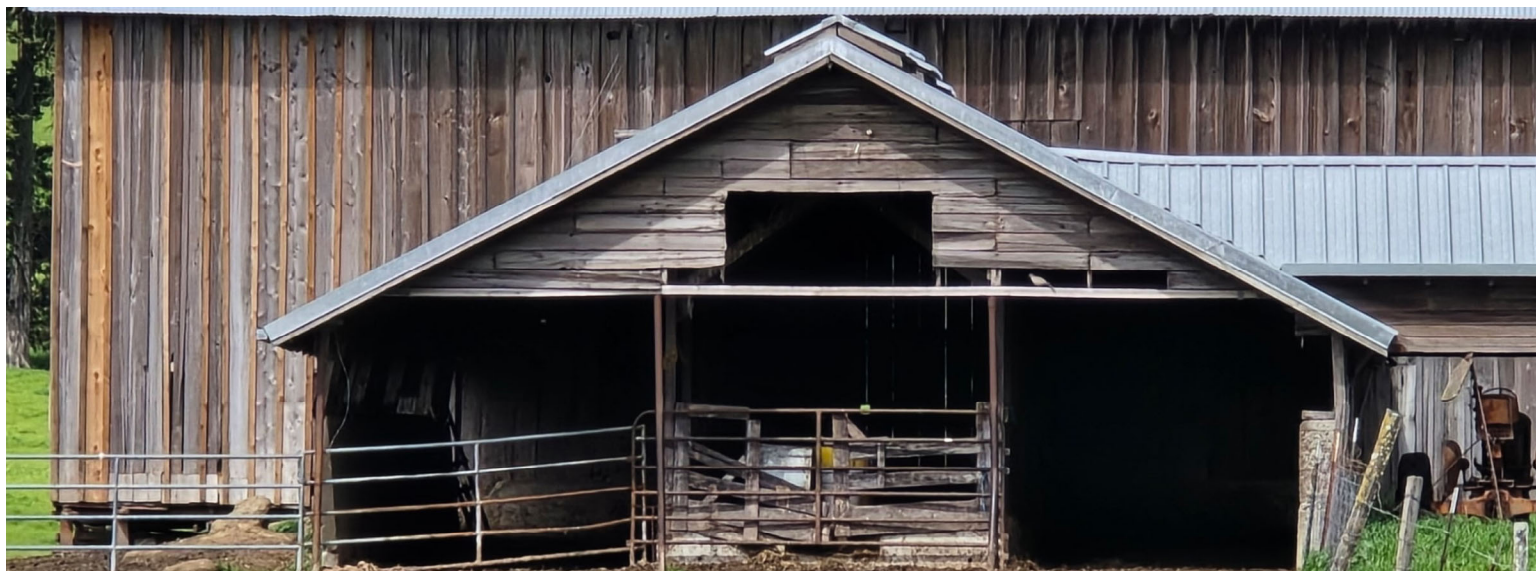
Dry cow barn to be used seasonally

- 8.) Dry Cow Barn Containment & Vegetative Buffer: Improvements were made to the dry cow barn. Dry cows will no longer utilize this barn during the rainy season. Manure produced within this barn will be scraped, piled, and removed prior to the rainy season. This rest period will create the opportunity for vegetation to grow and provide a vegetative buffer for future use during appropriate weather conditions.

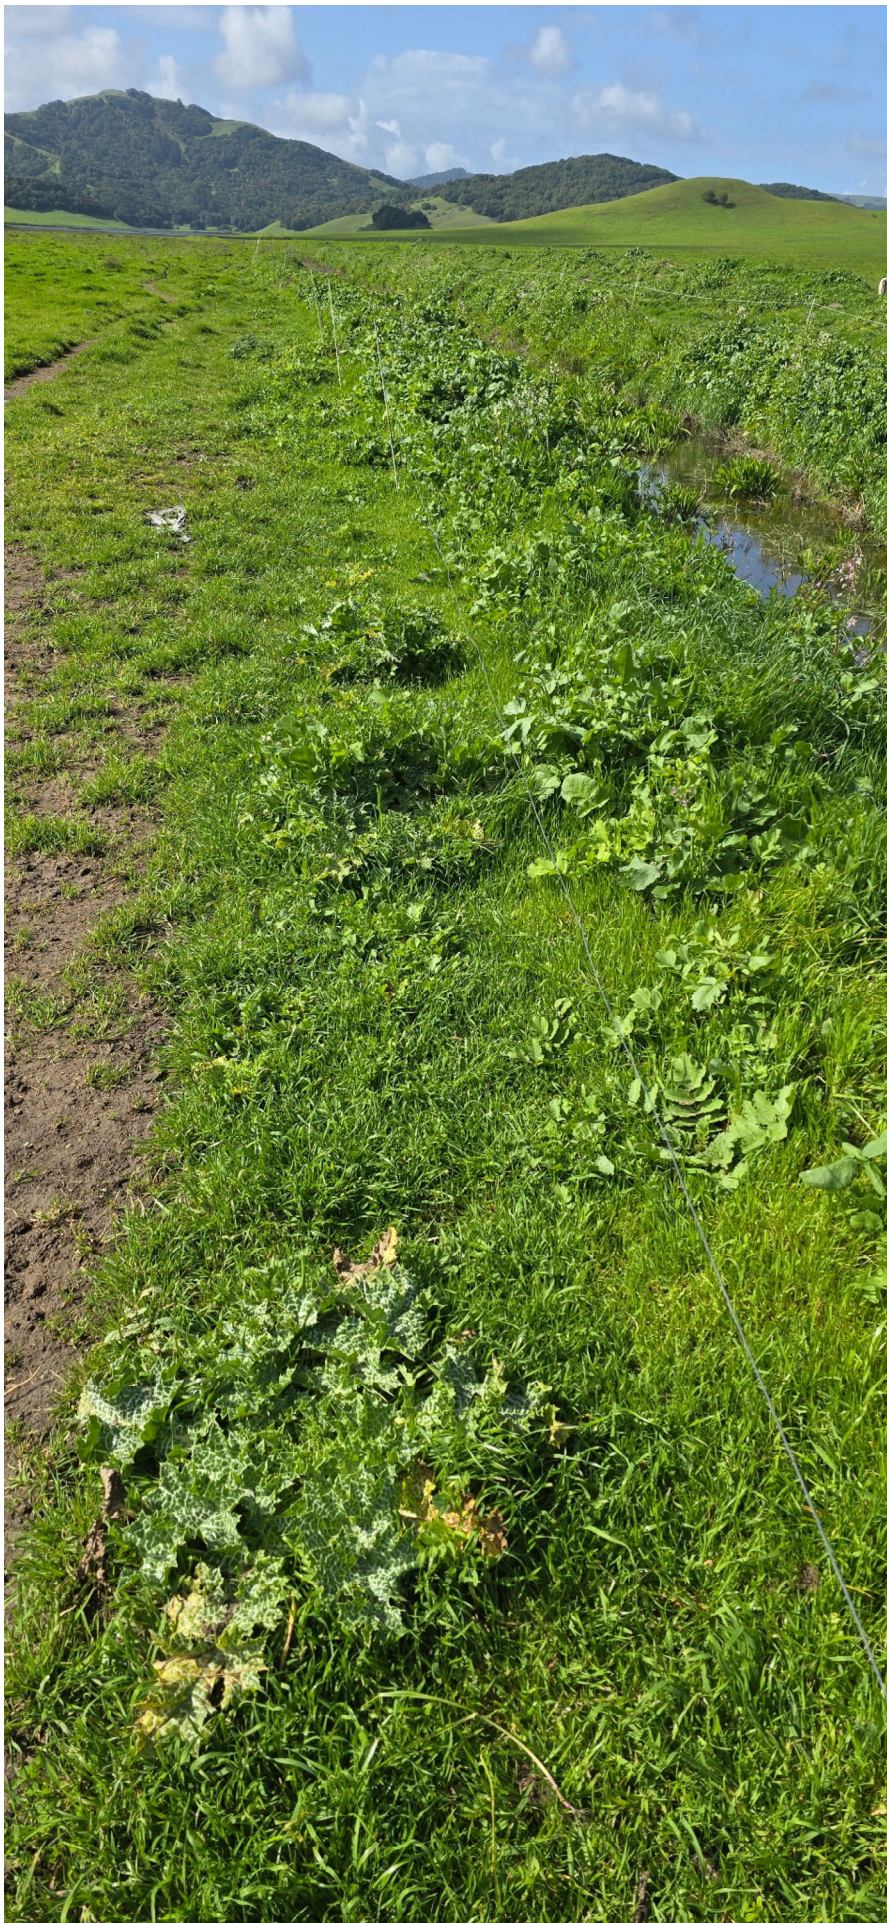
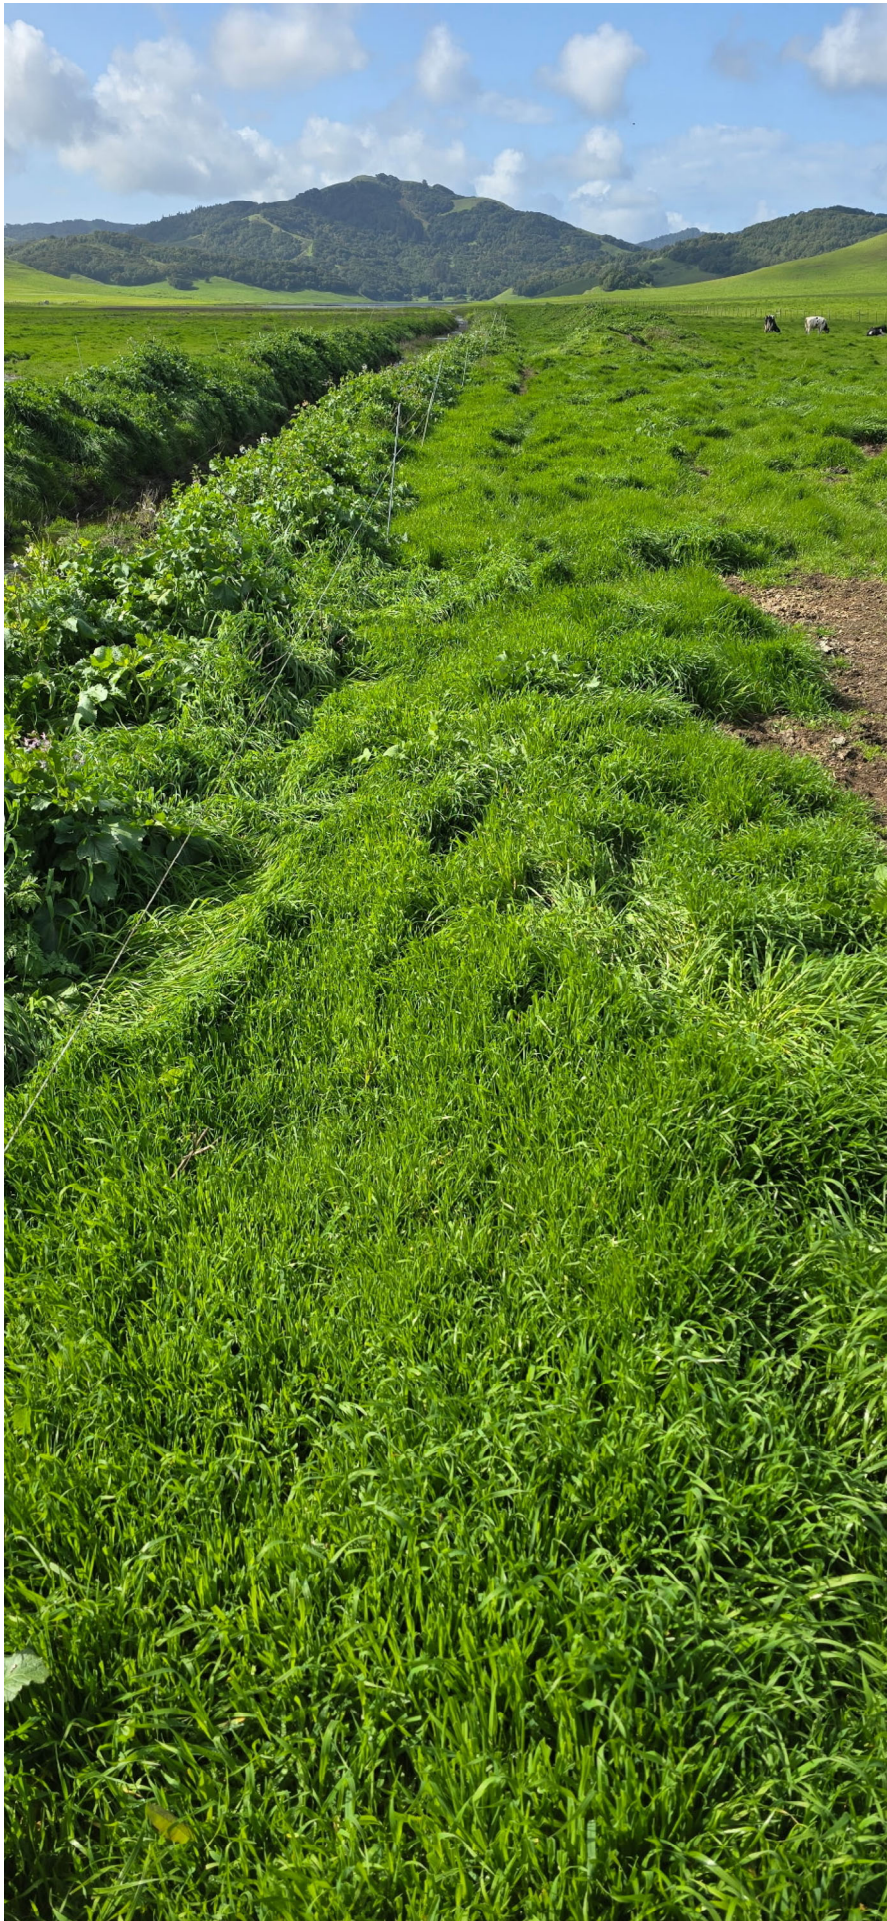
Electric fencing and vegetative buffer on both sides of creek

14.) Hot Wire Addition: The dairy has incorporated electric fencing technologies which will restrict livestock's access to any waterway in this area. The restriction of livestock access will allow for the further establishment of vegetation within the riparian area and protect water quality.

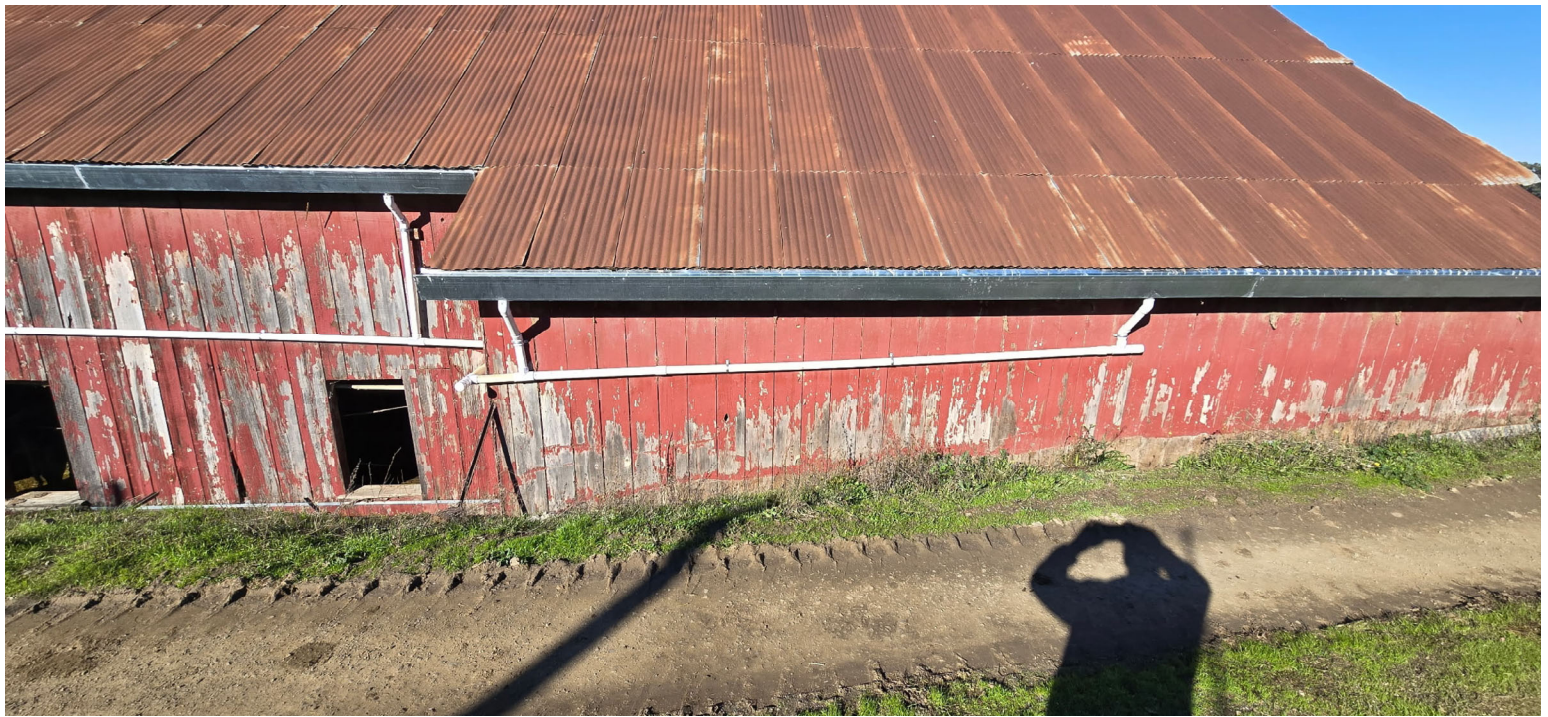
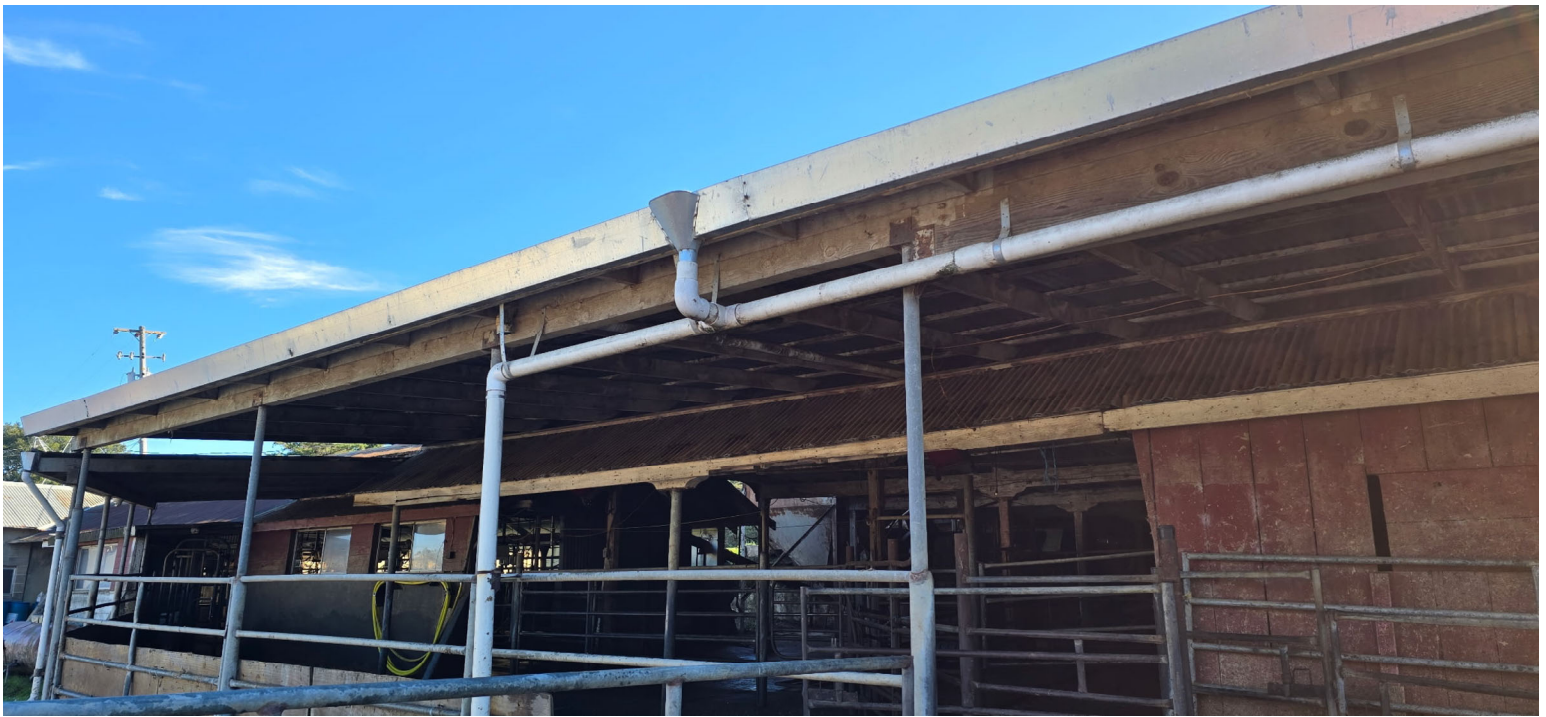
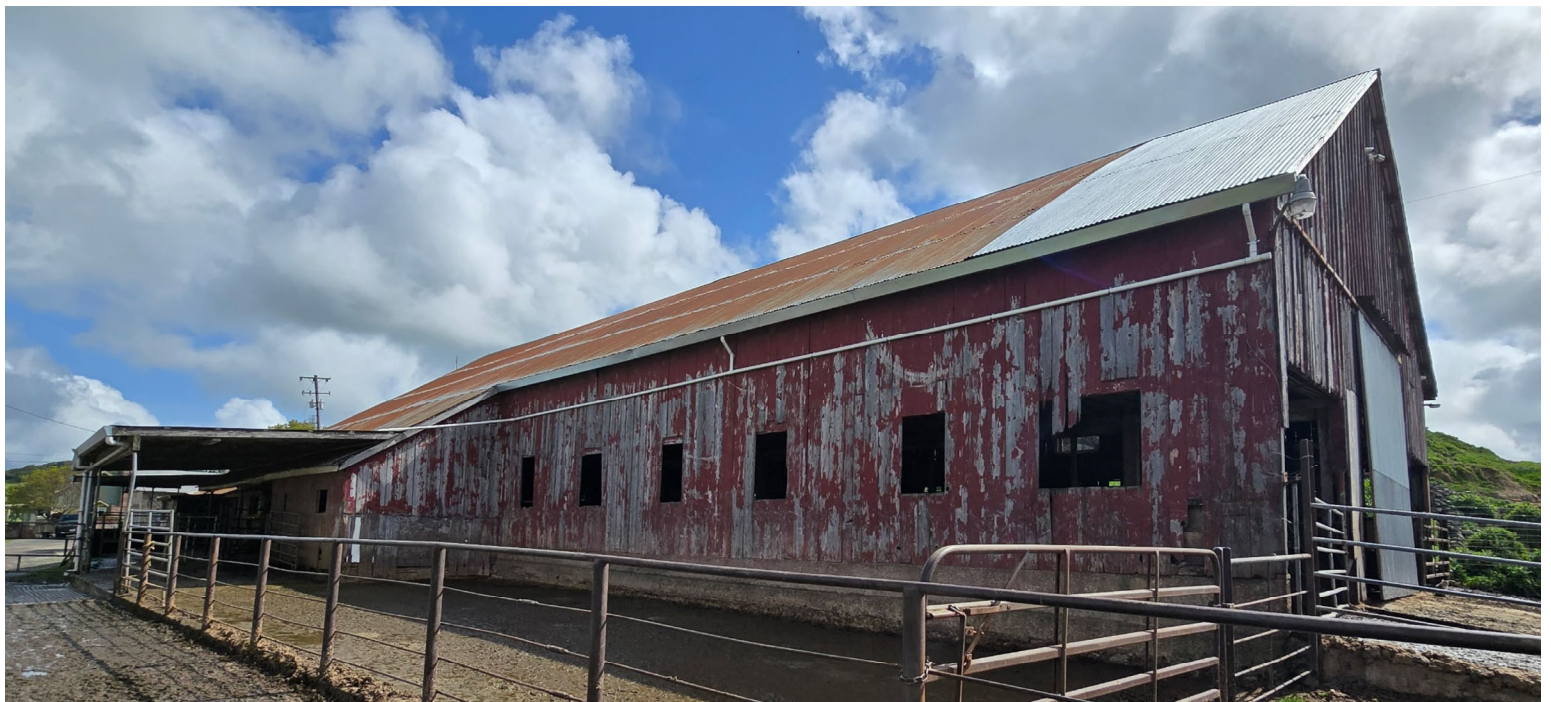
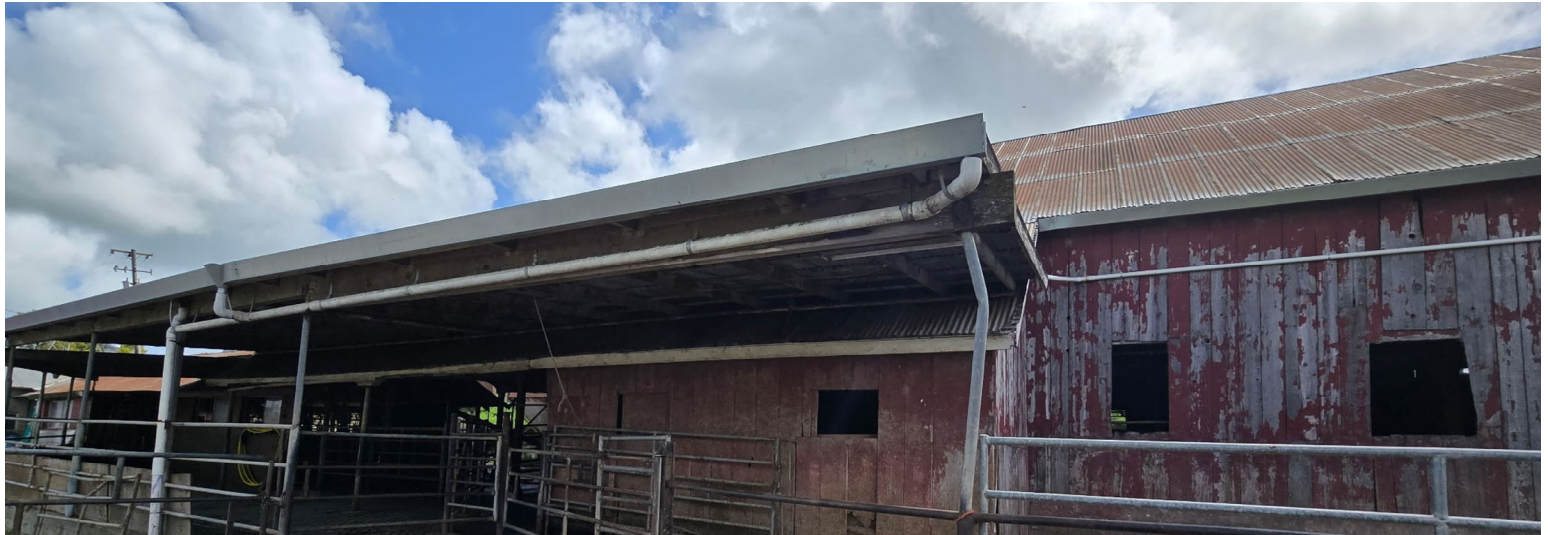
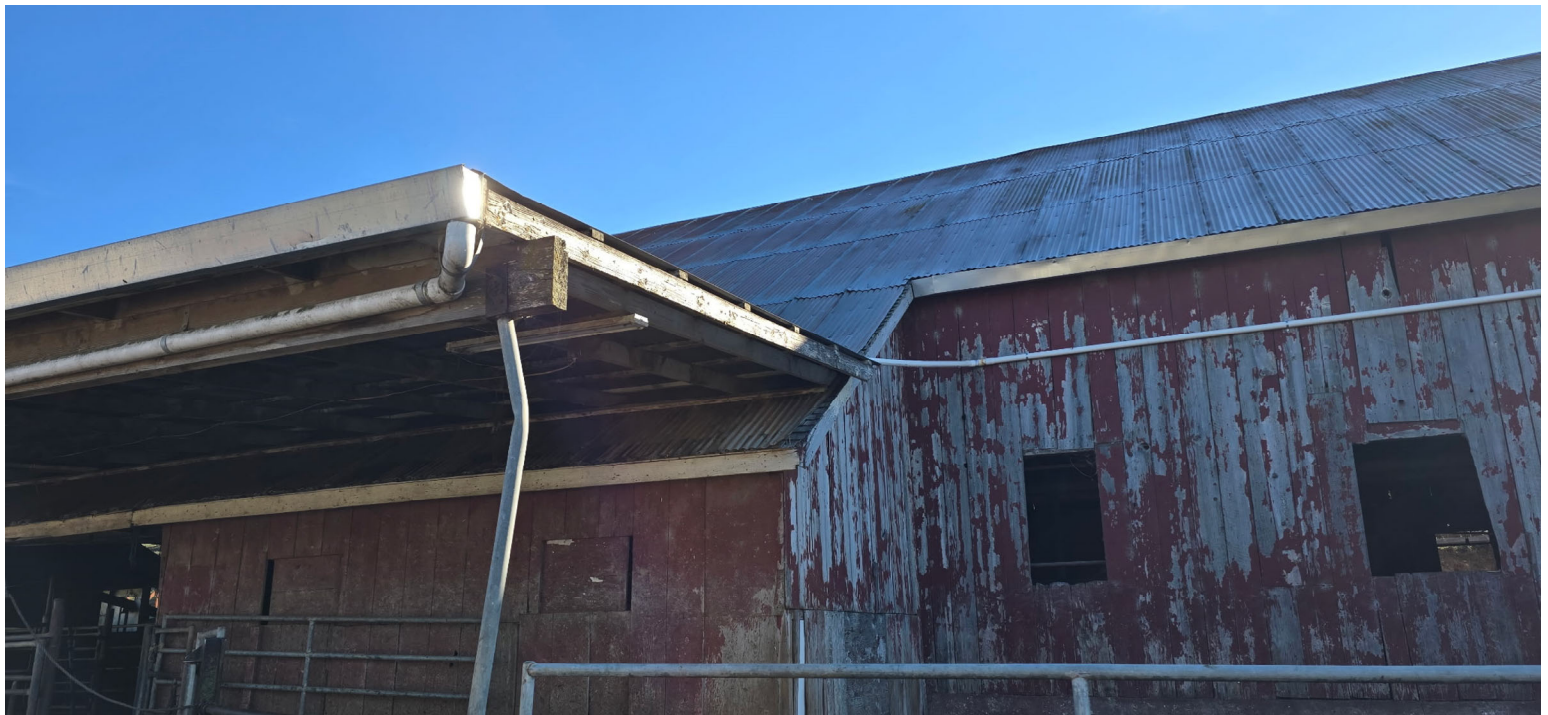
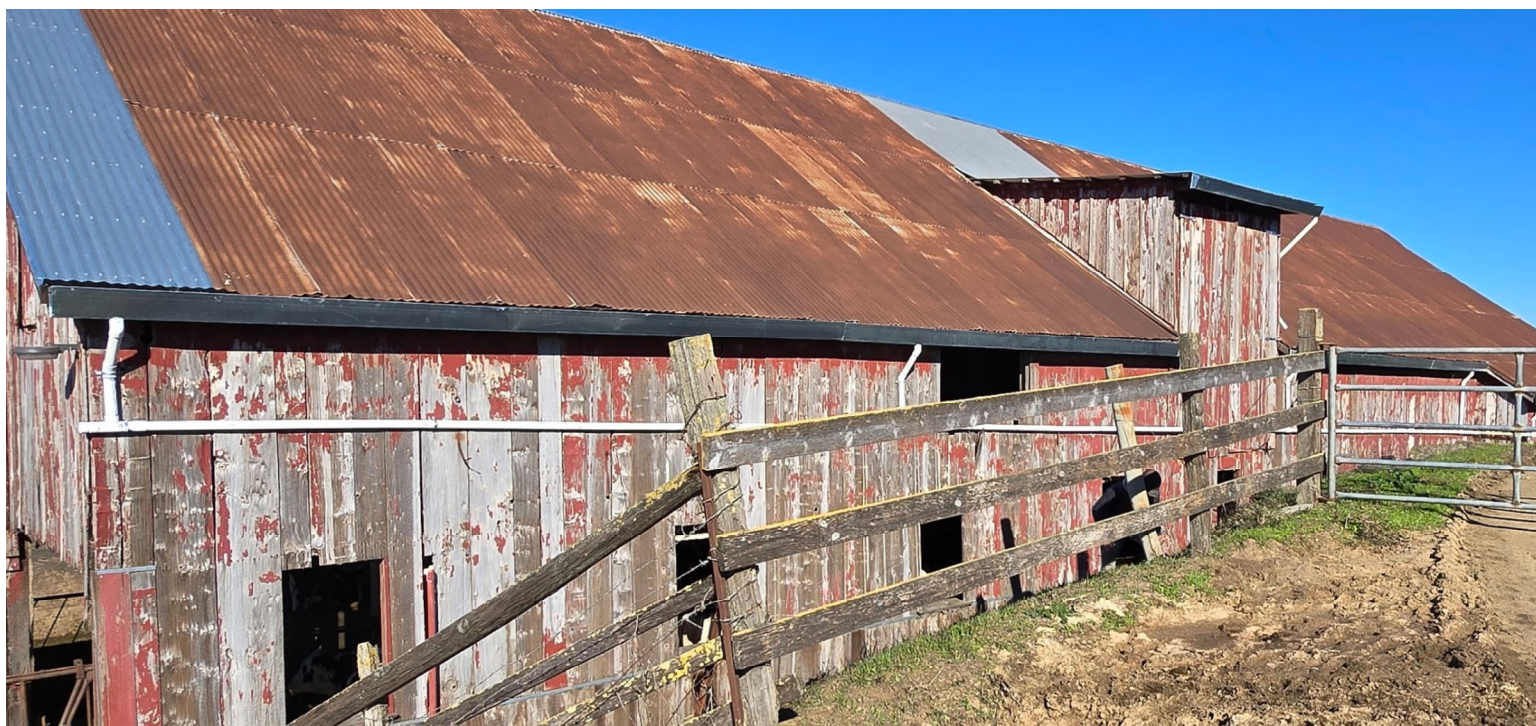
Milk barn gutters

- 6.) Milk Barn Gutter Cleaning & Plugging, Pipe Improvements: The dairy has cleaned its milk barn gutter, which was scraped clean and pressure washed. Any unnecessary drainage systems were plugged and are no longer in use. A pipe was repaired and is now fully functional.
